NV3AR

COMPONENTES/COMPONENTS/COMPOSANTS

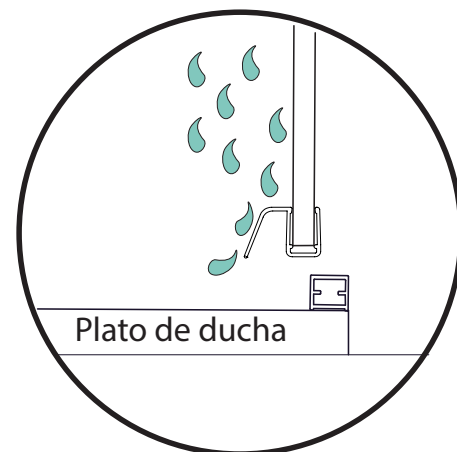
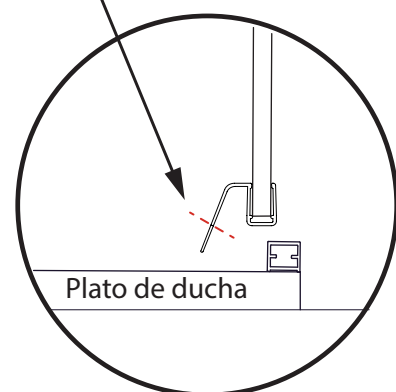
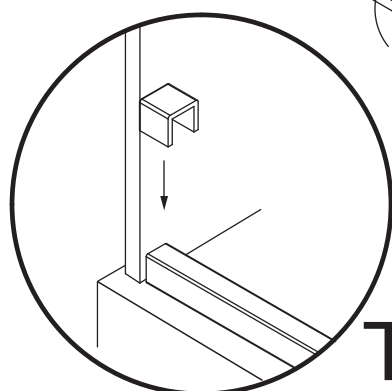
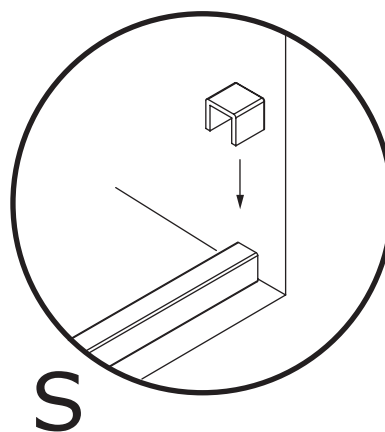
En el caso de que la junta roce demasiado con el vierteaguas, recortar la lengüeta para evitar que se pellizque

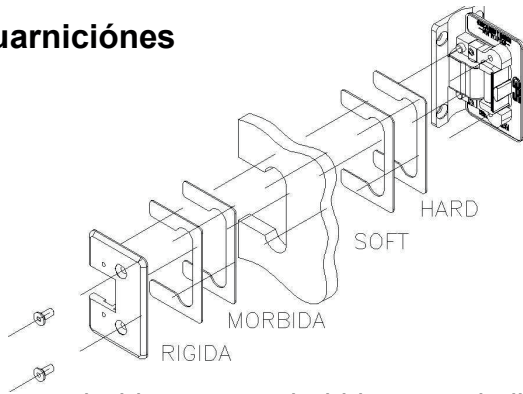
2 Guarniciones

Espesor del vidrio Glass thickness	6mm	8mm	10mm
Guarnición rígida Hard gasket	N°2+2	N°2	N°0
Guarnición blanda Soft gasket	N°2	N°2	N°2

Insertar la bisagra en el vidrio como indicado en el esquema sobrestante, respetando la cantidad y la secuencia de las guarniciones. (Si el espesor del vidrio es inferior del nominal, insertar la guarnición blanda adicional suministrada en la parte externa de la bisagra para asegurar un buen agarre). Se recomienda montar ante todo la bisagra en la puerta y después en la pared

Install the hinge in the glass according to the drawing above. Pay attention to the number and sequence of the gaskets. (In case of glass thickness is less than nominal value, add in the external side, the extra soft gasket supplied to ensure a good grip of the hinge). Advice: first install the hinge on the door then on the

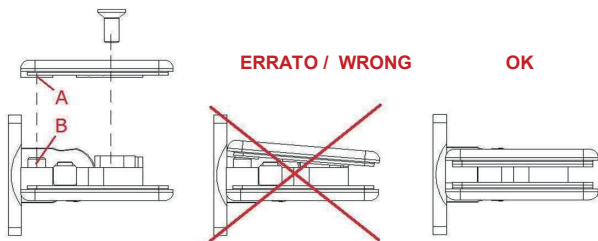
3 Cierre

atornillarla correctamente con los tornillos.

Reponer la contraplaca precedentemente removida.

Ponerse un cuidado especial de que la placa, a través de los agujeros A sean perfectamente acoplados con los pernos B. La situación el la imagen cruzada con X nunca debe presentarse, ya que eso podría implicar la possible ruptura del mecanismo. Una vez que se ha repuesto correctamente la contra placa,

Repose backplate previously removed **paying extreme attention** that the plate, through the holes A, matches perfectly with the pins B. The circumstance shown in picture B (crossed with x) should be carefully avoided as it might cause the breakage of the mechanism. Once it is successfully replaced, fix it to the plate with the screws.
